HARMAR REFUSE BANK

HARMAR COAL COMPANY

PHASE I INSPECTION REPORT  
NATIONAL DAM INSPECTION PROGRAM

JULY 1981

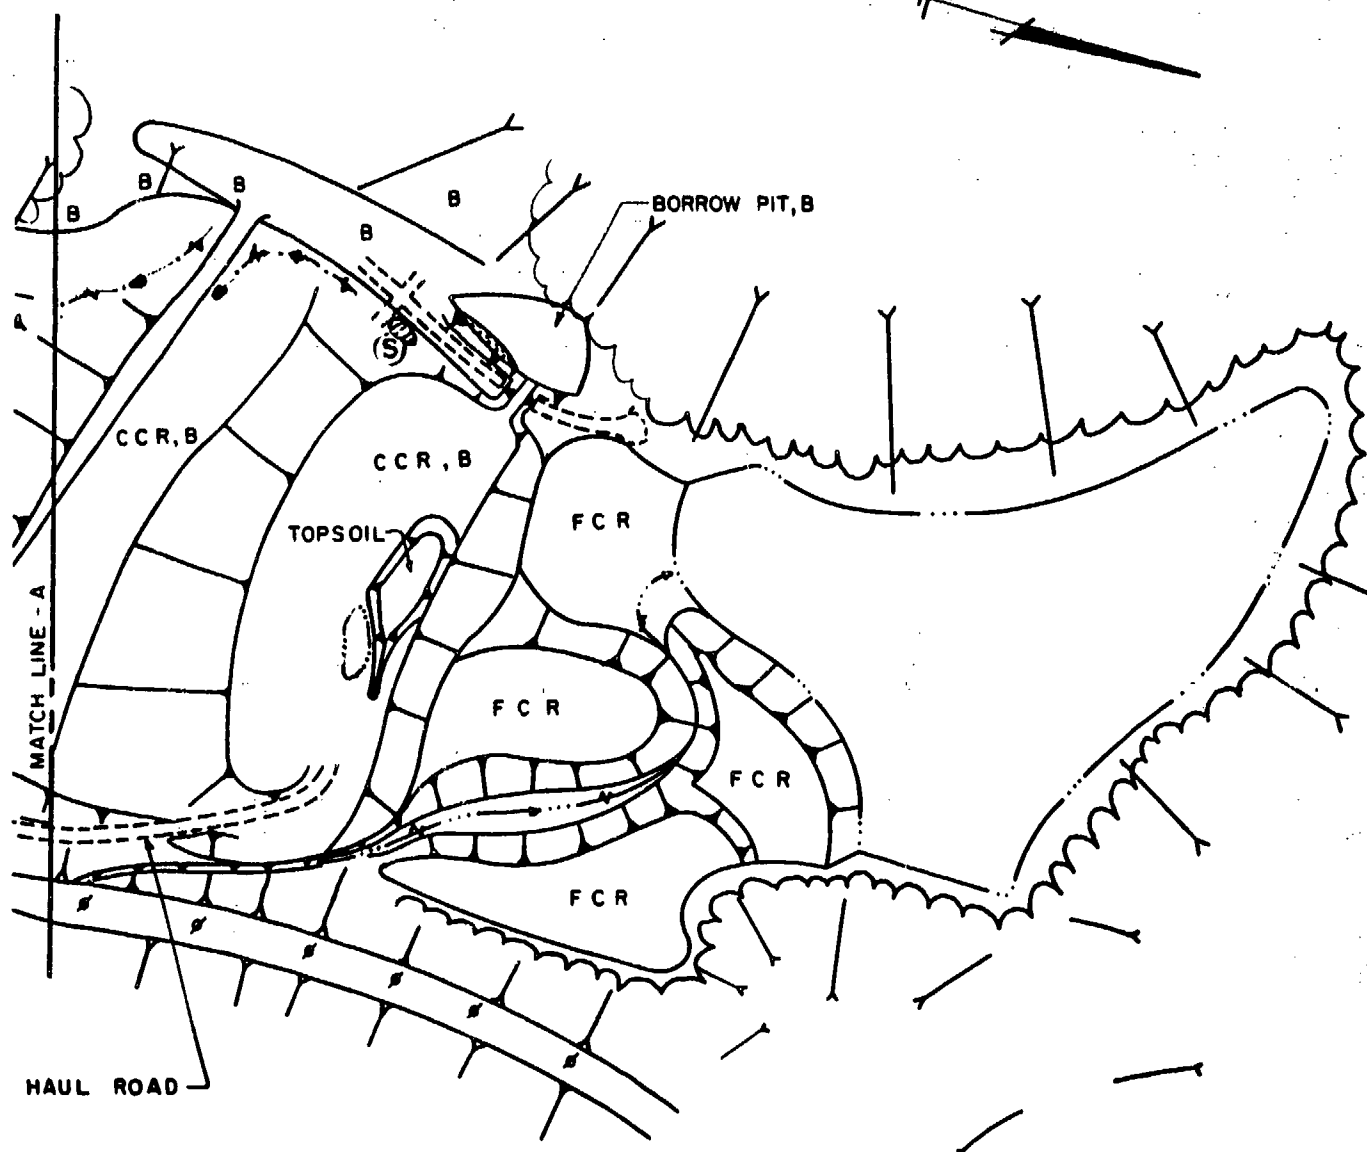
DATE: JULY 1981		HARMAR REFUSE BANK NATIONAL DAM INSPECTION PROGRAM		FIELD SKETCH  SHEET 1 OF 2	
SCALE: NONE					
DR: JF	CK: JEB	<b>ACKENHEIL &amp; ASSOCIATES</b> CONSULTING GEO SYSTEMS, INC. ENGINEERS 1000 BANKSVILLE RD./PITTSBURGH, PA. 15216			
DWG. NO. 80138 M-1

A fairly large slough zone has developed in the central portion near the left abutment. The slough is characterized by tension cracks and a small scarp near the top of the slough and hummocky, colluvial soils emitting seeping water near the toe. The slough appeared to be of a surficial nature and did not appear to threaten the overall stability of the embankment.

A significant slough zone exists on the left side of the lower portion of the downstream slope. A scarp several feet high and hummocky, colluvial conditions were observed. Springs and seeps were emitting iron stained water and water was ponded at several points in the vicinity of the toe of the slough. Trees on this portion of the bench were noticeably tilted in an upstream direction.

A wooden flume is located on the lower slope near the center of the embankment. The flume is quite old and wood has deteriorated and rotted at several points. A considerable amount of seepage was discharging from beneath the flume at the flume's downstream end and considerable iron staining and deposition of fine materials were noted beneath and immediately below the flume.

A significant slough zone was observed on the lower left abutment immediately above the rock fill toe buttress. The slough was approximately 100 feet long and 30 feet high, contained a significant scarp at the head and hummocky, colluvial soils near the toe. The slough appeared to have been revegetated and gave no indication of recent movement.

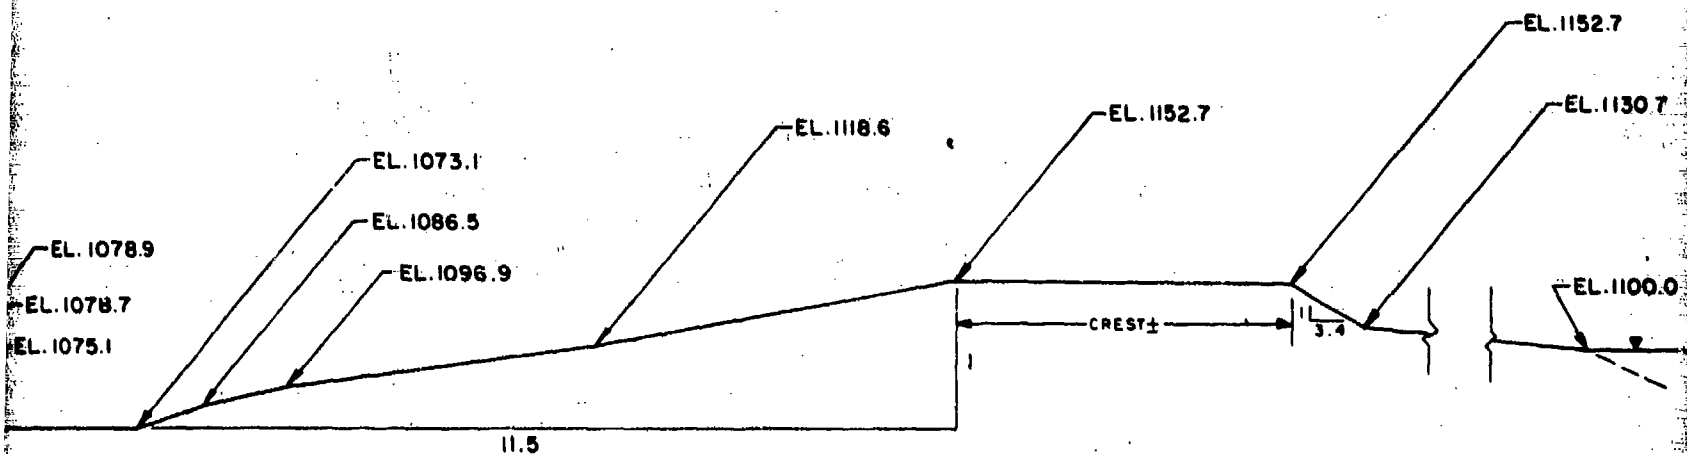
# SECTION THROUGH EMBANKMENT

The overall slope of the lower portion of the downstream face may or may not have an adequate margin of safety for certain embankment material and groundwater conditions.
